17 AUGUST MARMARA EARTHQUAKE AND THE PRECAST CONCRETE STRUCTURES BUILT BY TPCA MEMBERS

Hakan ATA KOY,
MSc, Civ.Eng.
Member of TPCA Technical Committee

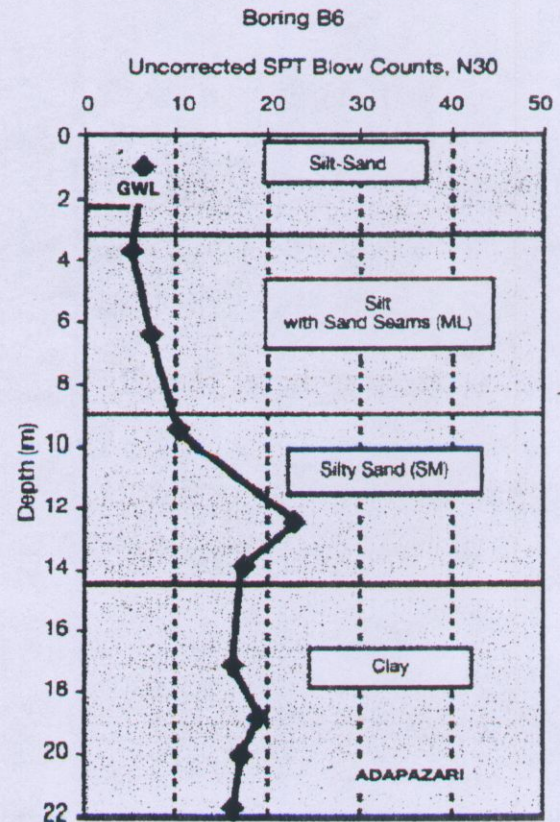
Figure 2 : Borehole log in Adapazari

Priority is given to the analysis of soil conditions and it is found out that water saturated sand-silt is the predominant soil formation. This type of soil is identified as group D, and classified as Z4 soil. (Fig.2)

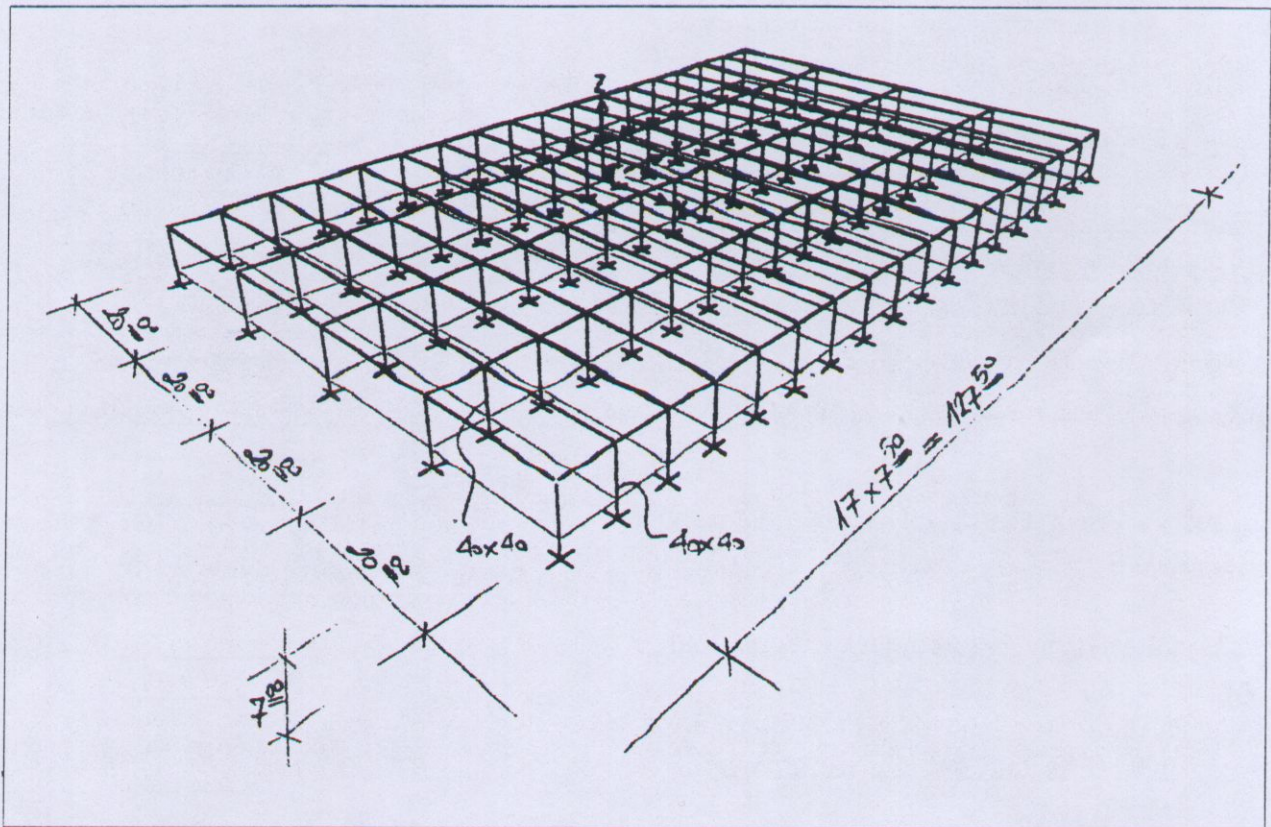
Figure 3: Building Type A.

The basic module is 20.00 m x 7.50 m and the height is 7.00 m. In both directions, hinge joints (with double pins) are used for columns and beams. Site investigations revealed that :

- It collapsed completely due to breakage and tilting.
- Direction of collapse is perpendicular to the main axis beams and the building collapsed after the inner columns broke off.

- c) Column sections are measured 40 cm x 40 cm.
- d) Column reinforcements are placed asymmetrically.
- e) All connections are hinge joints; roof beams being connected with double pins.
- f) There isn't any deformation or failure in column-socket connections.

1. Non-compliance with the Code.
2. Improper selection of design loads.
3. Not conforming with displacement limits.
4. Underrating the soil characteristics.
5. Asymmetrical positioning of column reinforcements.

The analysis proved that the main reason for collapse was "inadequate lateral rigidity". Following factors are identified as other reasons :

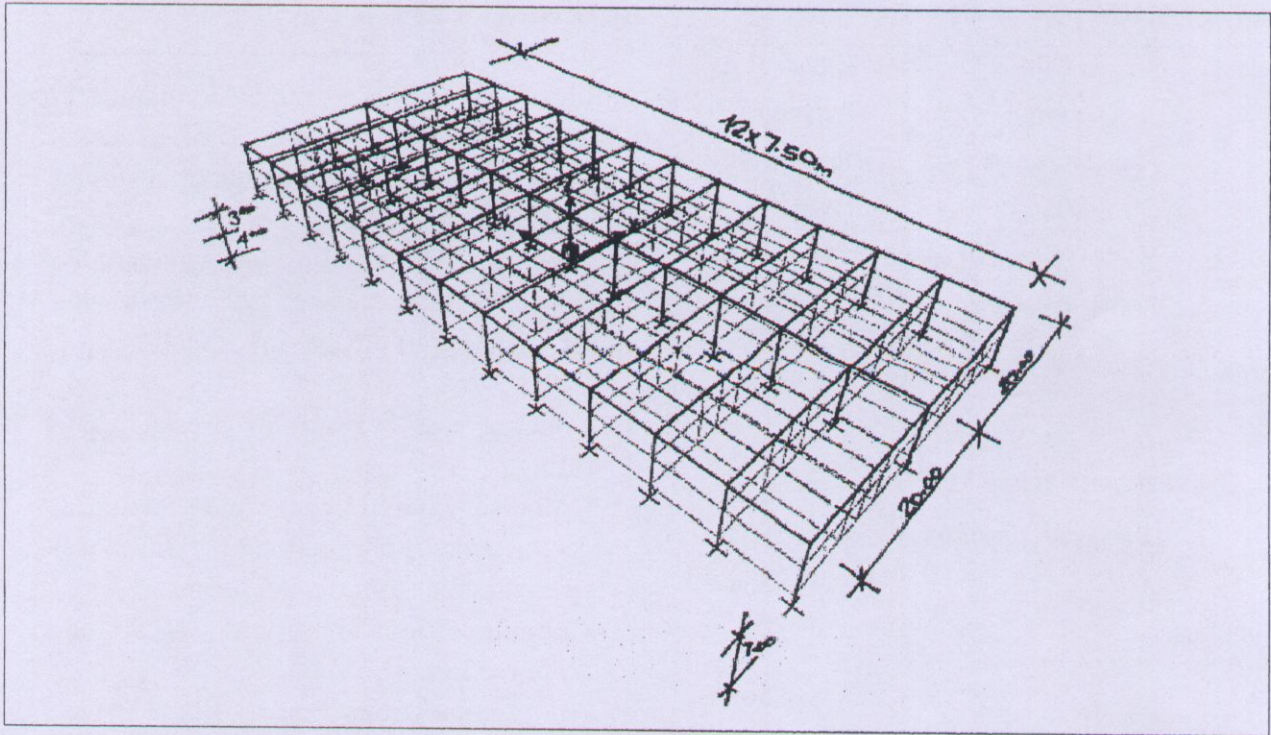
Figure 4 Building Type B

As illustrated in Fig. 4., the basic module in this building is again 20.00 m x 7.50 m and its height is 7.00 m. Connection detail is similar to building type A, but in this case, a groove is introduced. The building has a mezzanine floor and is built before 1997. Following points are noted in the site investigation :

- a) Collapse was a result of breakage and tilting.
- b) Collapse started with inner columns giving away and direction of collapse was perpendicular to the main beams.
- c) Column sections are 40 cm x 40 cm and 35 cm x 35 cm
- d) All connections are hinge type connections. Roof beams are connected with a single pin.
- e) Column beam and column gutter beam connections failed during the earthquake and some of the elements fell down.
- f) No deformation or failure have been observed in column-socket connections.

After the site investigation, the structural design is reviewed. Noting that the design was done in 1996, it had to comply with the 1975 Code. Analysis of the design showed in this case too, that inadequate lateral rigidity was the main cause of collapse. Following points, contributing to the collapse, have been identified.

1. Displacement limits of the 1975 Code are not complied with.
2. Inability of the peripheral beams to stand lateral forces due to poor connection details.

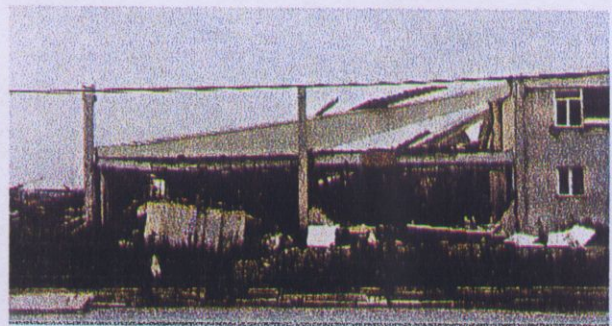
Photograph 2 Building Type B

The carbon ratio of the reinforcement steel in building type B was higher than the max. value of 0.45. This increased its brittleness and reduced its capacity for bending. In fact, in the tests ultimate strength was reached before creep started.

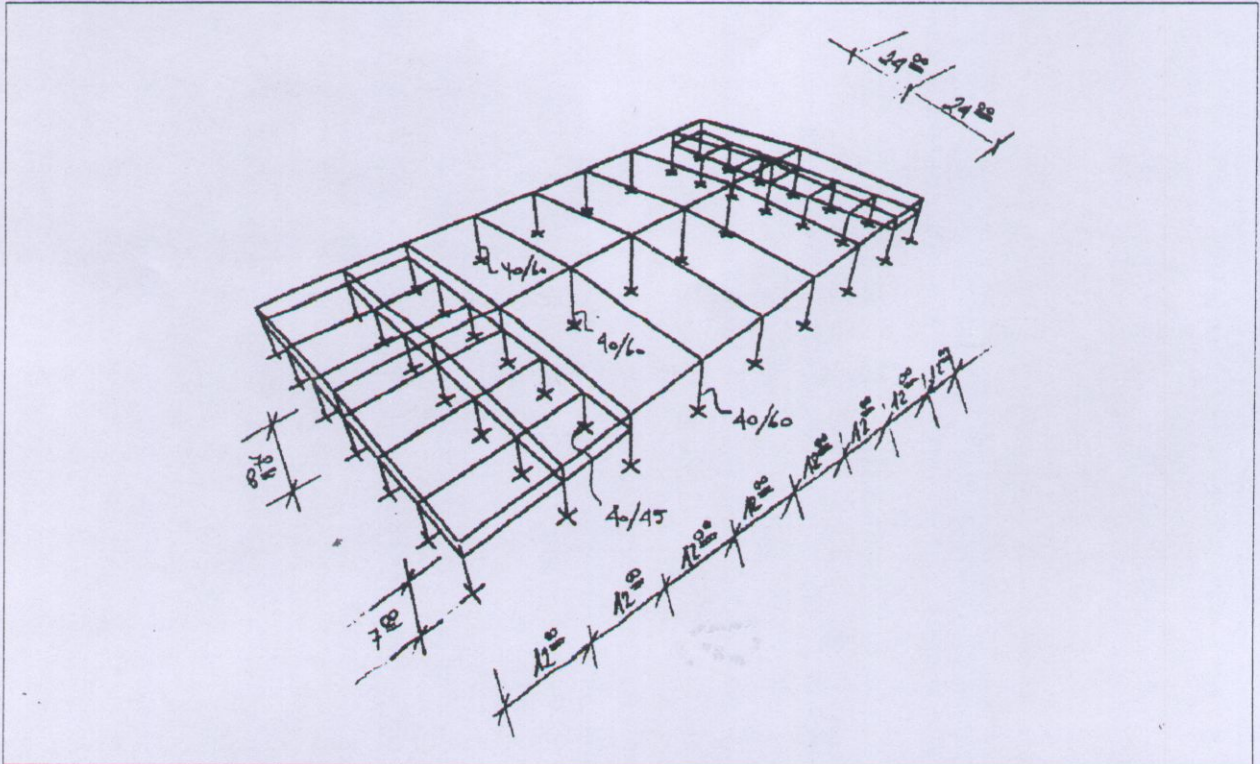
Figure 5 : Building Type C

In this case study, the basic module is 24.00 m x 12.00 m. Building height is 7.00 m around the periphery and 8.70 m along the central axis. (See Fig.5)

- a) The building collapsed due to breaking and tilting
- b) The direction in which the building collapsed is perpendicular to the main beams.
- c) Column dimensions are 40 cm x 60 cm in the main space and 40 cm x 45 cm over and under the mezzanine floor.
- d) Tie rods are used in beam to beam

connections and concrete corbel with a pin is used in beam to column connection.

- e) The columns failed in the direction where they were narrow.
- f) The building collapsed shortly after it was erected. Therefore it was subject to its own weight only.
- g) It is observed that in some of the beam to socket connections, mortar fill was not in place.

Both the design and construction was done in 1998. So the structural design is reviewed in accordance with the 1997 Earthquake Code. (Refer to Tables 11-12-13-14) The main reason for the damage was inadequate lateral rigidity as in the previous cases and following errors have been identified :

1. Non-compliance with the 1997 Earthquake Code.
 - a) Incorrect load assumptions.
 - b) Not confronting with the displacement limits
 - c) Underrating the soil characteristics.

2. Lack of design check for the weaker direction.
3. Inadequate reinforcement.

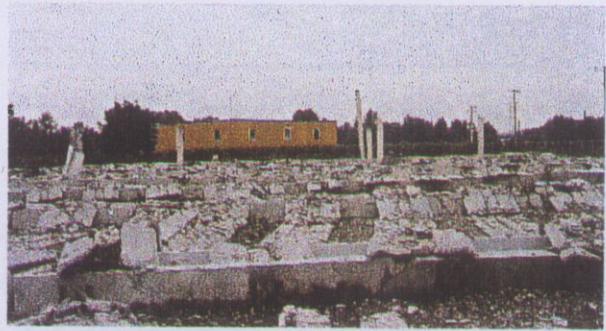
Photograph 3 Building Type C

In building type C, although S 420 steel was specified in the design, the samples yielded questionable values of creep and ultimate strength.

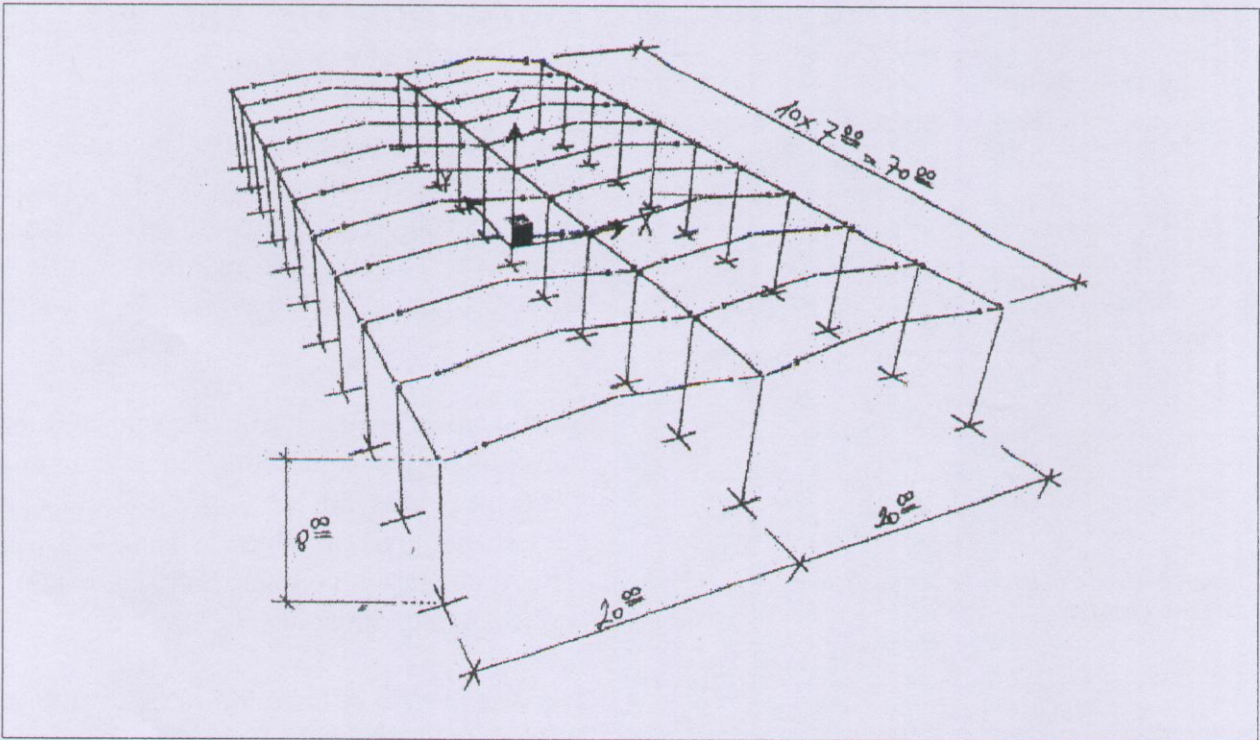
Figure 6 Building Type D

As illustrated in Fig.6, the layout is based on a 20.00 m x 7.00 m module. Maximum height of the building is 8.0 m. The system is composed of L and Y elements which are connected at points where moment is zero. Following points are observed during the studies on site:

- a) Horizontal elements in both directions fell down due to failure of the connecting equipment.
- b) Columns which were disconnected from the beams managed to stand erect.
- c) Inner columns are broken down into two.
- d) Collapse or snapping and falling occurred along the shorter side of the columns.
- e) Column dimensions are all 25 cm x 50 cm.
- f) At the time of the earthquake, the weight of the building included only that of the structural frame and roofing.
- g) No deformation or failure is observed in column to socket connections.

1. The main reason leading to collapse was "inadequate lateral rigidity". This was a consequence of :
 - a) Not complying with the 1997 Code.
 - b) Insufficient performance of connecting equipment
 - c) Weakness of the system against lateral forces.

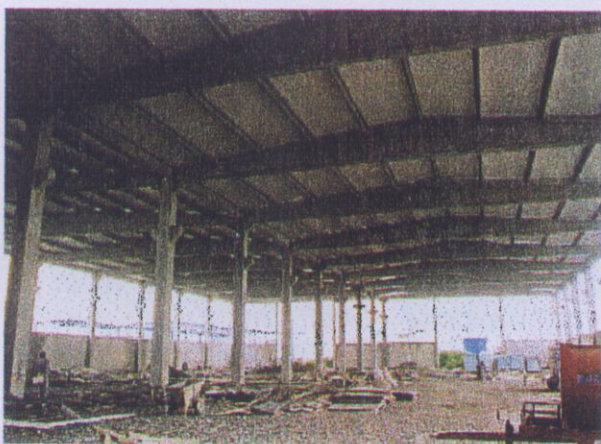
Photograph 5 An undamaged precast concrete structure

In the earthquake that occurred on 17 August 1999 in the Marmara Region of Turkey, some single storey, reinforced precast concrete buildings with hinge joints are either damaged or have collapsed. This damage is neither a result of the design method, nor of the materials and the construction technology used. Incorrect applications are to be blamed for this result. The common problem in all the collapsed buildings is ignoring the existing design rules and regulations set by the Codes. The technical teams of Turkish Precast Concrete Association observed that the buildings that have been designed and produced in compliance with existing Earthquake Code, have suffered very little or no damage. Even in areas where devastating effects of the earthquake is mostly felt, there was no damage in the buildings where only the column dimensions were correctly selected. (Photo. 5)
